Degraded Medium Frequency Receive Antennas

Dallas Lankford, 8/10/2011, rev. 8/18/2011

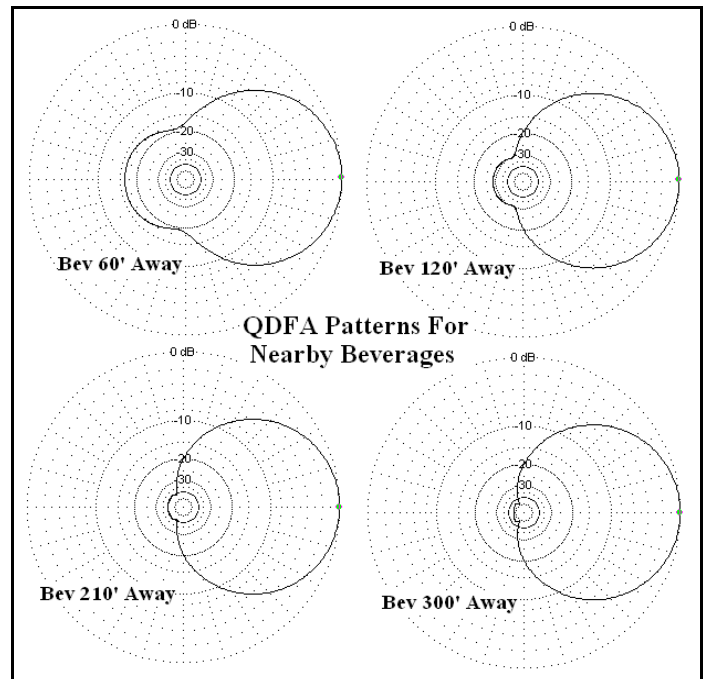
Nearby antennas, especially beverages, can spoil the pattern of a QDFA or DDFA. EZNEC simulations at right, for an unterminated beverage, with open circuit input, illustrate some of the QDFA patterns for nearby beverages. For a beverage connected to an independent 450 ohm source, the QDFA pattern is not degraded as much. However, it is not known if these EZNEC simulations give an accurate description of the skewed QDFA patterns. As a rule of thumb I would recommend that no part of a beverage antenna be closer than 300 feet to a QDFA or DDFA, and even that may not be enough. I do not know of any way to settle these issues. Other antennas may not degrade the QDFA pattern as much as beverages, but who knows?. Personally, I would not use any other antenna near a QDFA. EZNEC simulation also shows that nearby power lines can significantly degrade a QDFA pattern, especially for a power line at one end of and perpendicular to a QDFA.

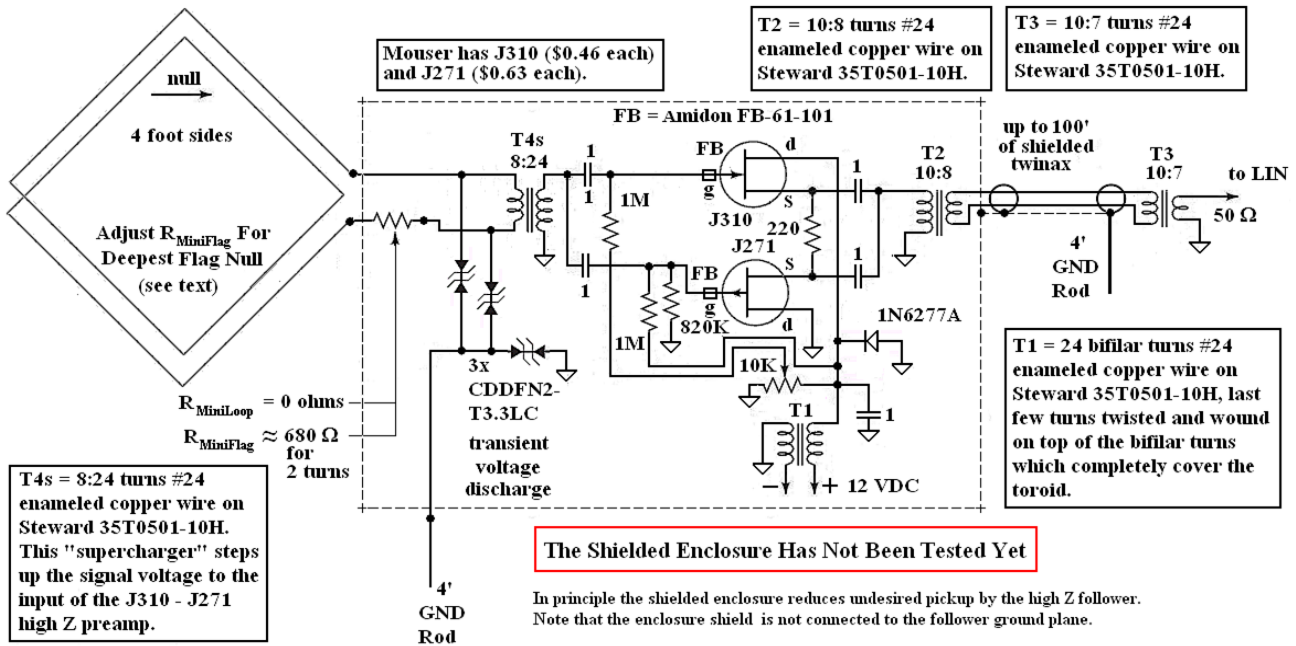
Supercharged MiniFlag And MiniLoop Antennas

This is a small active loop or active flag antenna with performance almost equal to a full size (~500 sq. ft.) passive loop or passive flag antenna.

The 2 turn miniflag schematic he used above is one of the original schematics with an incomplete description of the 2 turn miniflag. A more recent schematic is given below.

The antennas in The Dallas Files are provided as is, and most of them are works in progress. Consequently, there are aspects of those designs which are not optimal. For example, the output impedance of the J310 – J271 complementary pair is about 150 ohms (measured). So the 12T:12T output transformer I used originally is not optimal. IV3PRK chose to use the word **wrong** (see his statement in his description above), and then proceeded to change the turns ratio to 14T:8T, which changed the impedance step down to 3.06. So he matched the output impedance to 50 ohms. I wonder why he did that.
